SUBSYNCHRONOUS VIBRATION IN A LARGE WATER FLOOD PUMP

James E. Corley

Supervisor, Rotating Equipment

Arabian American Oil Company

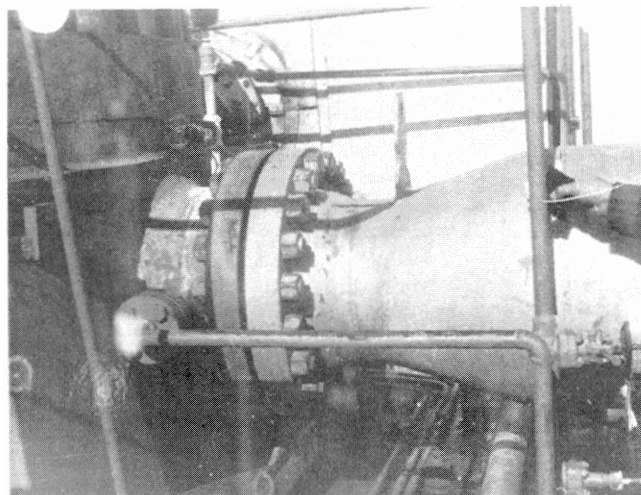
Suction for the booster pumps is taken from a common header which feeds two injection trains in a given plant. The booster pump then supplies suction to the shipper through a pipe loop approximately 75 feet long, which can be seen in the aerial photograph in Figure 4. The suction and discharge piping is connected to the pump through bell shaped transition pieces. These transition pieces, shown in Figures 5 and 6, were later found to be a prime factor in the sub-synchronous vibration of the pumps.

Figure 5. Original Shipper Pump Suction Transition Piping.

1. Clearances within the machine were such that shaft movement produced pressure or flow variations and light damping.
2. These pressure pulsations could be reflected back into the machine by the abrupt expansions of the transition pieces in the discharge piping.

Using the hypothesis just described, it was proposed that the abrupt piping area changes be eliminated and replaced with transition pieces which had a much longer taper. We arbitrarily selected a L/D ratio of three to one for this change. Because of press of time, it was not possible to have the transition piece rolled in a normal manner. We, therefore, had the transition pieces fabricated by the orange peel method, that is, sections of the pipe were cut out and the discharge transition piece produced as shown in Figure 11. Since we still were not absolutely certain that interactions on the suction side of the pump were not causing problems, transition pieces with the long tapers were installed on the suction also, Figure 12. Unfortunately, due to the pressure to solve the problem as quickly as possible, we were forced to change more than one variable, the piping and also the wearings. Therefore, for the initial test, we would not be certain as to which modification produced the solution; changing the piping or changing the wearings.

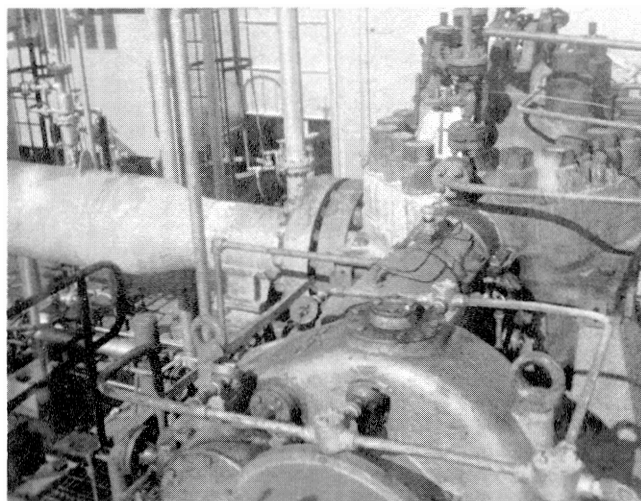
Figure 6. Original Shipper Pump Discharge Transition Piping.

1. The sub-synchronous vibration on the shipping pump was caused by hydraulic pulsations which were reflected from a sudden area change in the discharge piping. This energy excited the rotor's fundamental mode and produced a coupled hydraulic-mechanical self excited resonant system.

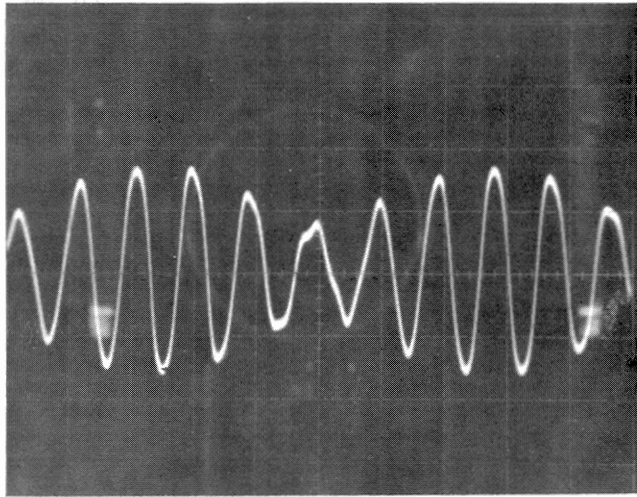
At a speed of approximately 3,300 RPM, a new characteristic became evident. This vibration pattern is shown graphically in Figure 7 as a beat frequency. Prior to this time, we had felt we were dealing exclusively with a one frequency problem. As the beat frequency pattern became evident, it was obvious we were dealing with two discreet frequencies which

were close together. As we brought the machine further up in speed, the beat frequency decreased and the amplitude of the vibration increased. As the two frequencies became separated further, we were able to discriminate between the frequencies with our manual tunable filters. Taking the unit up towards its maximum speed, it was apparent that the sub-harmonic frequency remained relatively constant as the running speed increased. A plot of this vibration is seen in Figure 8 which shows vibration spectra as a function of a pump speed. As can be seen on the curves, the sub-harmonic vibration component increased in frequency slightly with running speed and the amplitude increased dramatically. The unbalanced running speed component of the unit increased as one would expect due to unbalance. At 4,600 RPM, which was the maximum speed we dared take the unit, the inboard bearing was showing a shaft amplitude of 20 mils. Needless to say, the data taken at this point was sparse. We brought the unit down in speed noticing the beat frequency until we dropped below 3,500 RPM.

Figure 7. Beat Frequency Vibration Pattern.

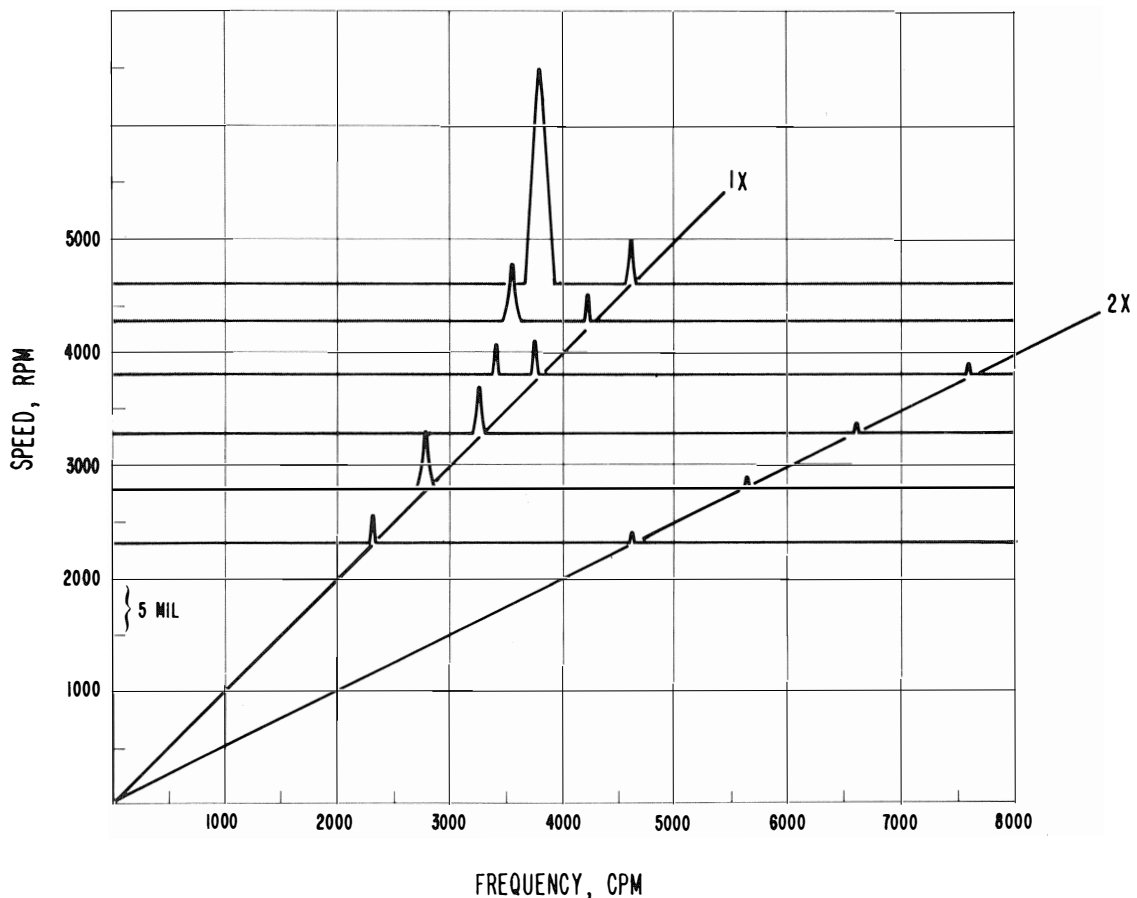
Figure 8. Horizontal Shaft Vibration at the Inboard Bearing.

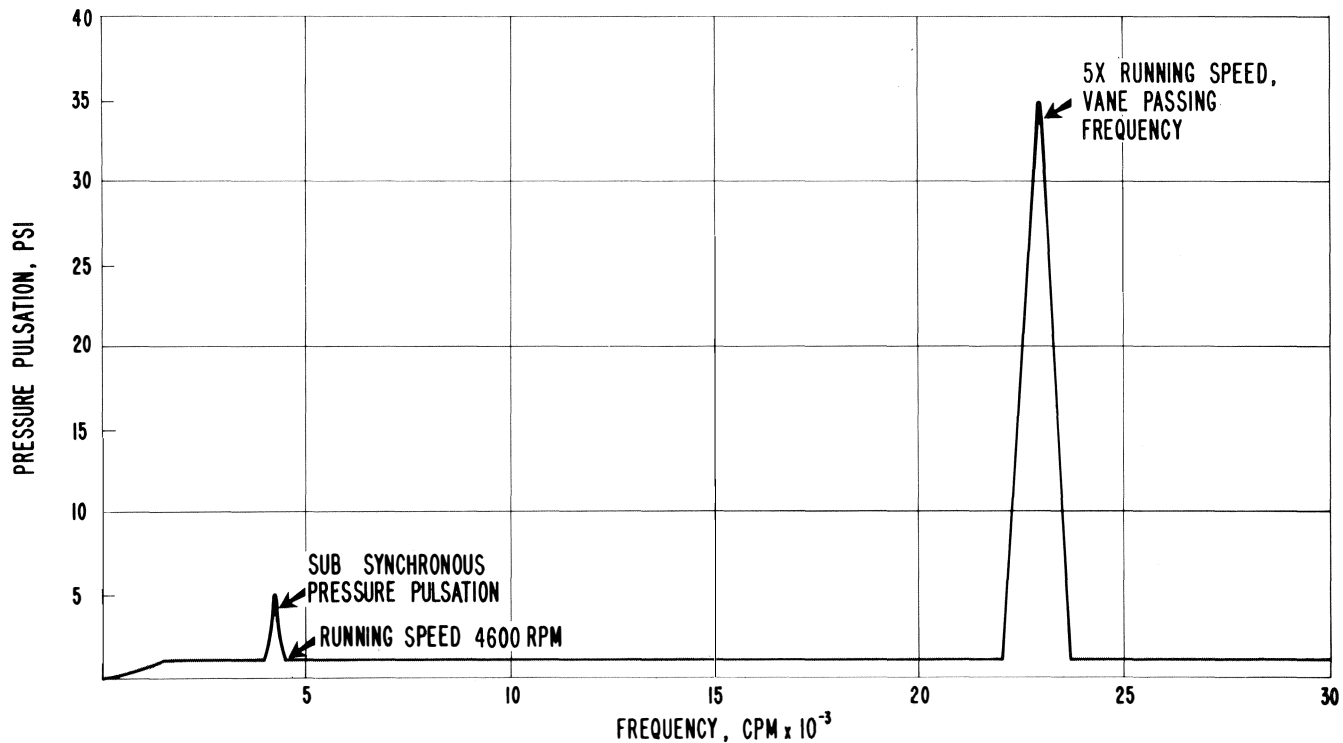
Figure 9. Pressure Pulsation Spectra as Measured in the Discharge Piping.

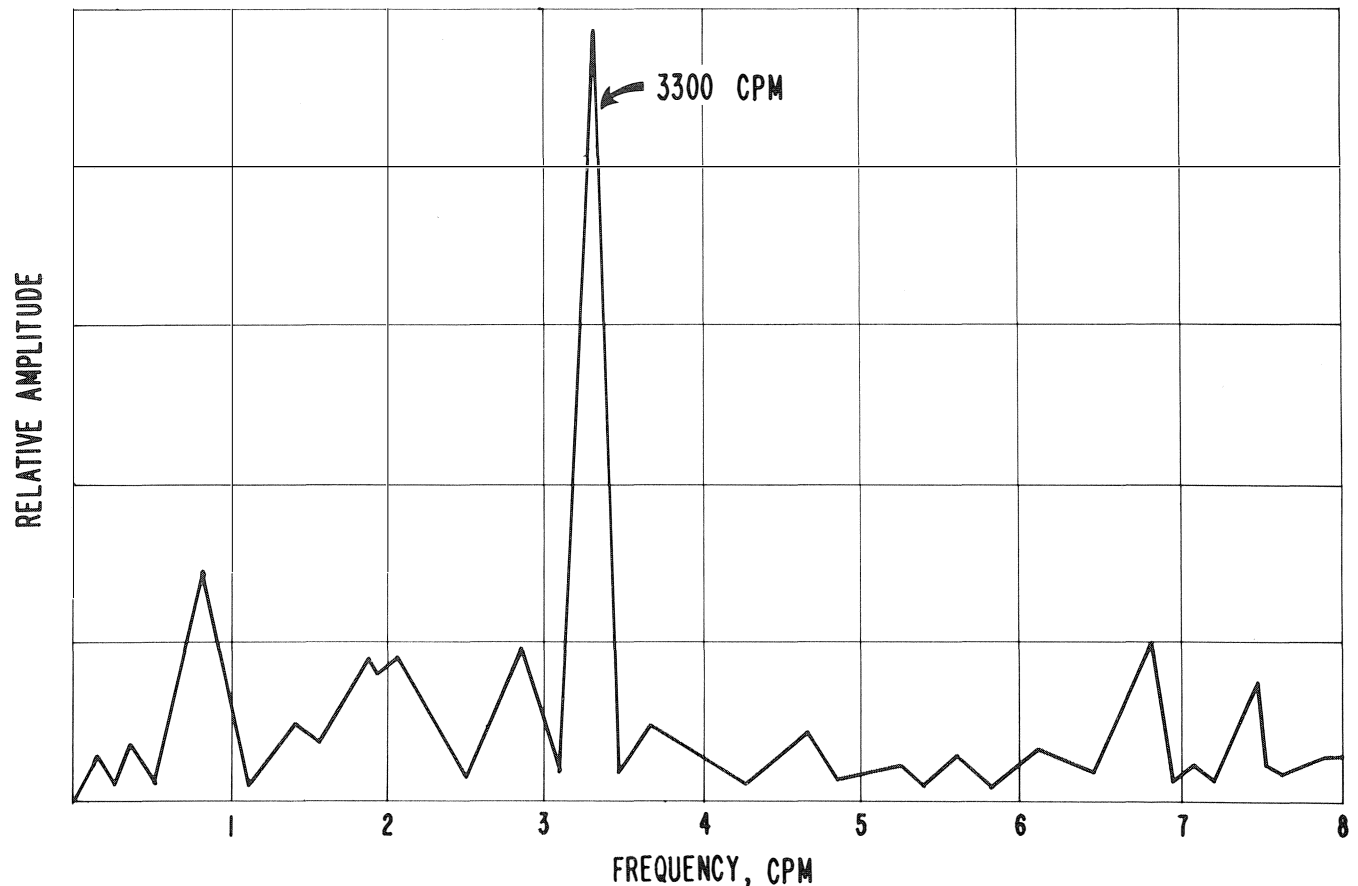
To investigate this resonance question, a pump element was tested in the shop by supporting the shaft on V-blocks and measuring its response to impact with a real-time spectrum analysis. The response, shown in Figure 10, verified that the

Figure 10. Impact Response of Pump Rotor.

fundamental frequency was 3,200 to 3,300 CPM or very near the speed where the sub-synchronous vibration started. It is still uncertain as to the reason the synchronous forces have never excited this mode.

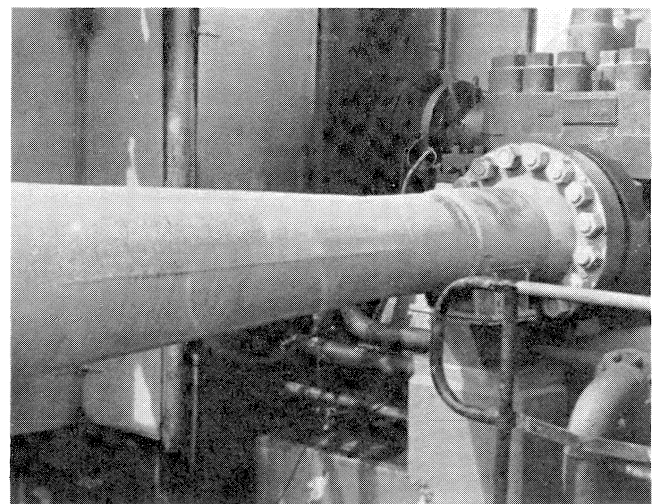
Figure 11. Modified Long Taper Transition for the Pump Discharge.

cases, the only modification made was the piping change from an abrupt expansion to a long taper. These changes proved highly successful in that the sub-synchronous vibration was completely eliminated on all machines. The long tapers proved so successful in eliminating the problem that a program was implemented to change the piping on all 16 injection and shipping pumps in the water flood system and has since become our standard discharge piping configuration on all higher energy shipping pumps.

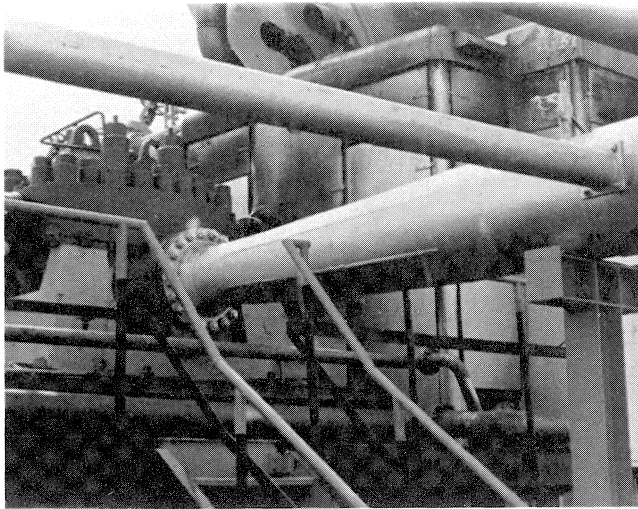
Figure 12. Modified Long Taper Transition for the Pump Suction.

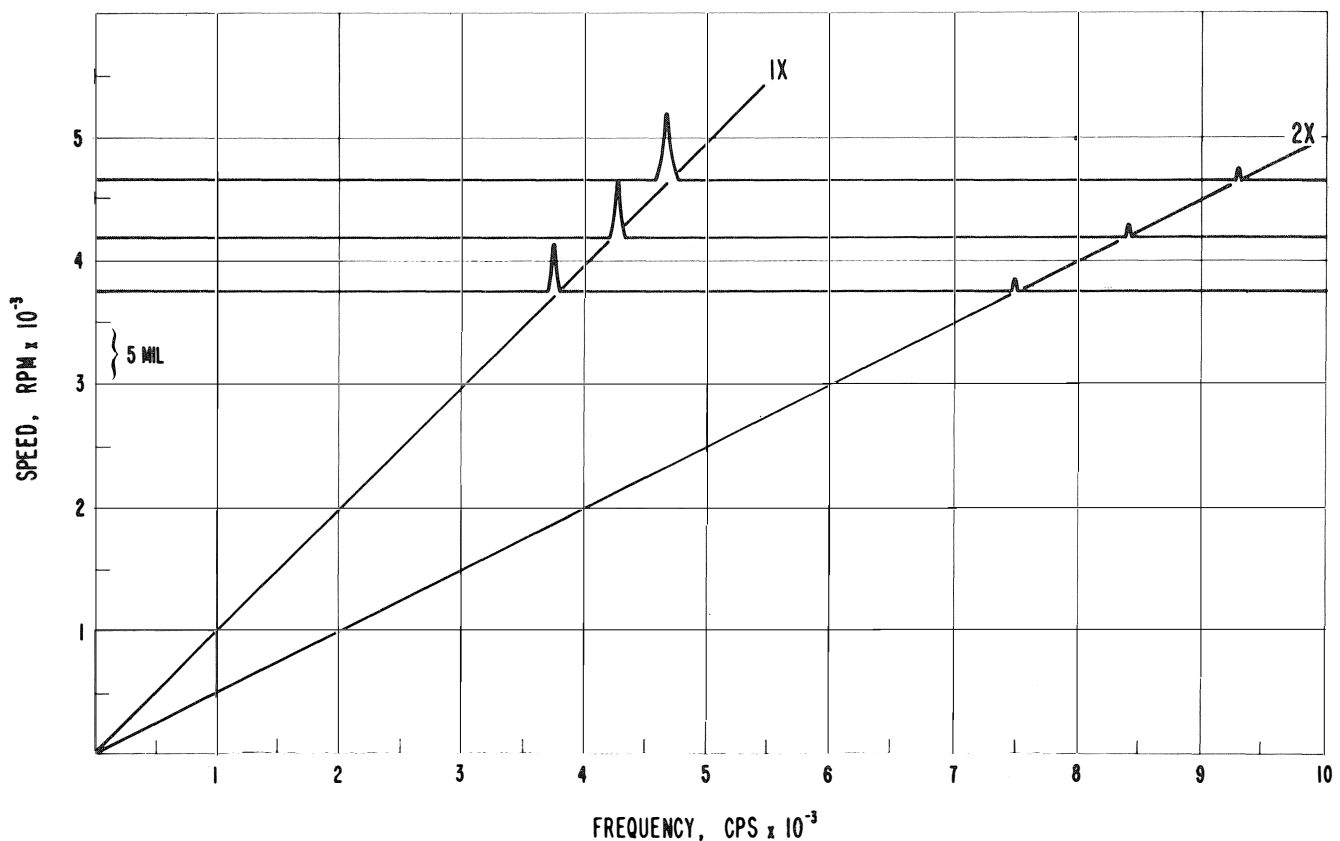
motion and pressure pulsations on the discharge. During this test, the unit was brought to the design speed of 4,750 RPM with no evidence of the sub-harmonic excitation. The vibration patterns of the shaft, shown in Figure 13, indicated a

maximum of 5 mils on the inward bearing at running speed. The outboard bearing vibration was on the order of 2 mils.

Figure 13. Vertical Shaft Vibration on the Inboard Bearing after Installation of Long Taper Transitions.

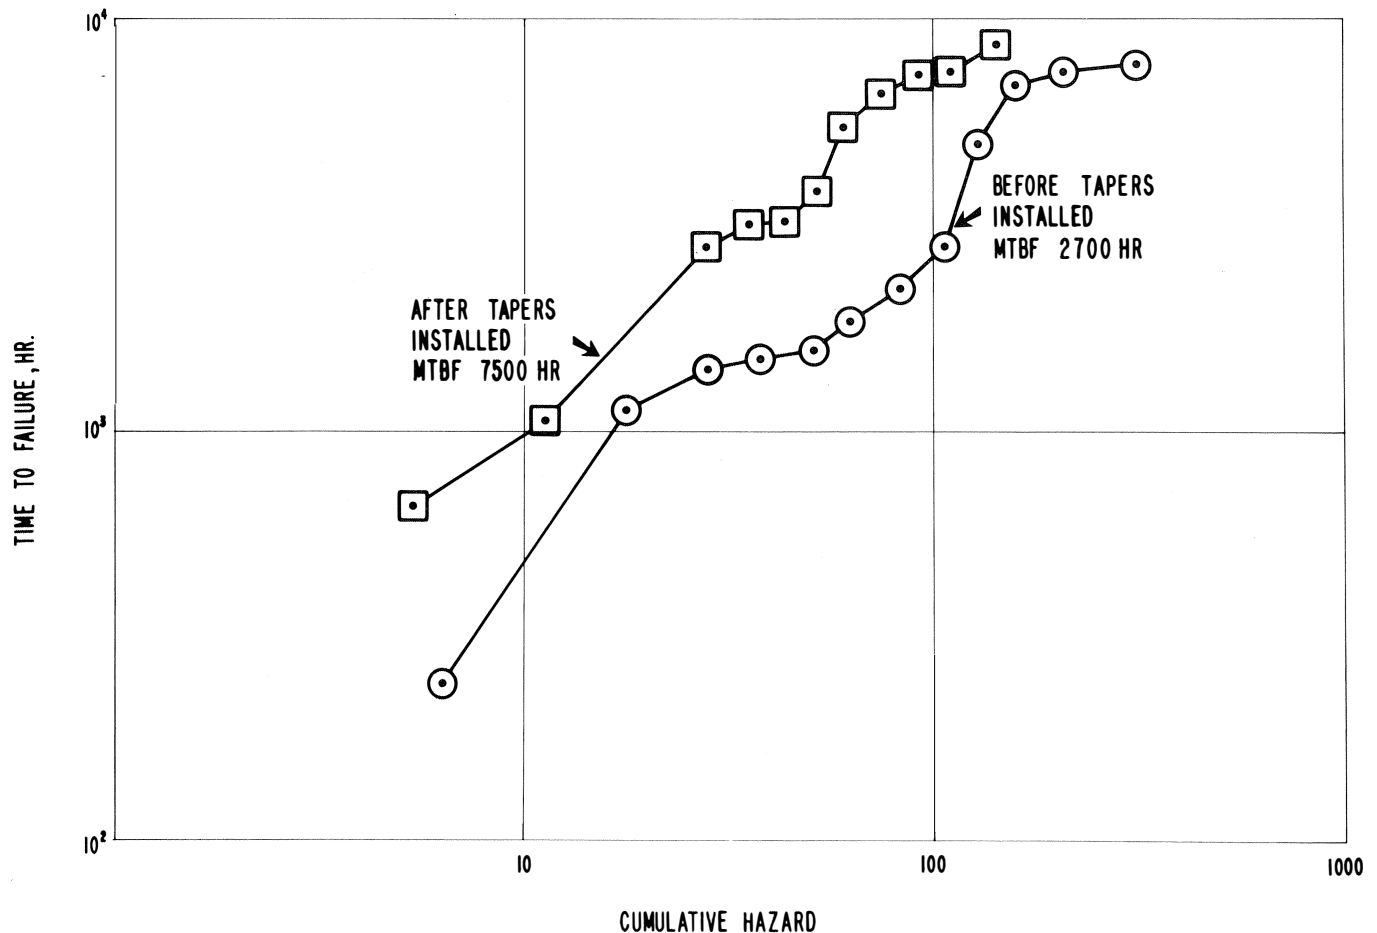
On many of the injection system pumps there had been a problem with impeller vane cavitation and breakage. Before implementing the long taper program, we were sustaining impeller failures of the order of 2,700 hours. After implementing the long taper changes, the mean time to failure of the impellers increased to 7,500 hours as is seen on the hazard plots in Figure 14. It is suspected that this improvement in impeller life is due to the smoothing of the flow entering the pump through the suction transition.

Figure 14. Improvement in Impeller Life after Installation of Long Taper Transitions.
